**TEST REPORT**  
**EVALUATION OF DAMPERS WHEN SUBJECTED**  
**TO SALT SPRAY ASTM B117**

RE: OBSERVATION REPORT - EVALUATION OF 5 DAMPERS WHEN EXPOSED TO  
1000 HOURS OF SALT SPRAY TESTING ACCORDING TO ASTM B117

SPECIMEN NO.	IDENTIFICATION
A	Series 1500 SW -Marine Anodized Spec
B	Series 1500 SW- Standard Spec
C	Series 1500
D	Brand X Stainless Steel
E	Brand X Galvanized Steel

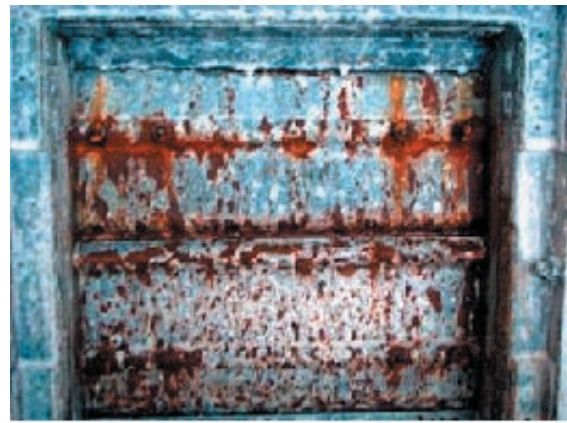
Galvanized Steel

SAMPLE A	no change	no change
SAMPLE B	no change	no change
SAMPLE C	no change	40 to 50% dark spots
SAMPLE D	no change	no change
SAMPLE E	#2	Rust stains are worse. Linkage has a heavy build of approximately 95% covered by rust
